City of Baltimore Wet Smoke and Dyed	Page 1 of 2	
Sewershed: Gwynns Falls	Company: Savin	Date: 4/22/2009
Test to be performed:  Smoke Dyed Water X	Ground Condition:  Dry ✓ Damp ☐ Wet ☐	Supervisor: JAW
Manhole_ID: S07MM1036MH	Test ID: <u>D1032-034012</u>	Notification Made: NA (Residents, Fire, 311)

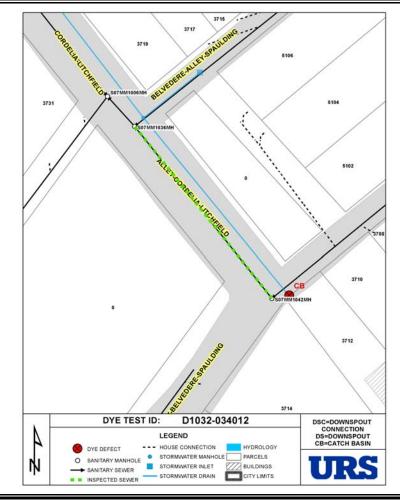
Field Sketch: Show all manholes with Numbers, Blower Placement Locations, Sandbag or Isolation Locations, Street Names, Building Addresses and Locations, Defect Locations and Photo Numbers.

Defect Loc	Obs_ClockFrom	Obs_ClockTo	Observation	Obs_Remarks
0			Start of Survey	
0			Manhole	S07MM1036MH
0			Water Level	
4	07	04	Roots Fine Joint	
13.80000019	07	05	Deposits Attached Encrustation	
19.89999962	07	04	Roots Fine Joint	
68.30000305	03	10	Roots Fine Joint	
76.80000305	07	05	Deposits Attached Encrustation	
76.80000305			Manhole	S07MM1036MH
76.80000305			End of Survey	
76.80000305			Dye Test Visible	IN MH 036,FROM DROP LINE
